SIGMA MONITORS

TOEI COLOR DISPLAY / MODEL TC-V814H

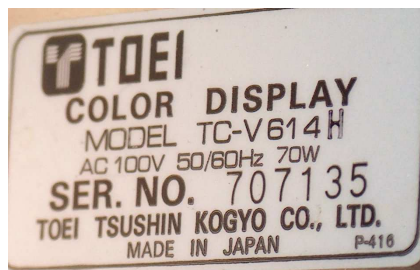
Vert Height

C49 & C71 100uF 35V
