CAPITAL VENDING, INC.

Technical Bulletin

CHANGING MOTORS IN A USA BILL ACCEPTOR FITTED WITH A PLASTIC MOTOR DRIVE CHASSIS

REPLACEMENT OF TENSION LEVERS IN USA³ AND DBA ACCEPTORS

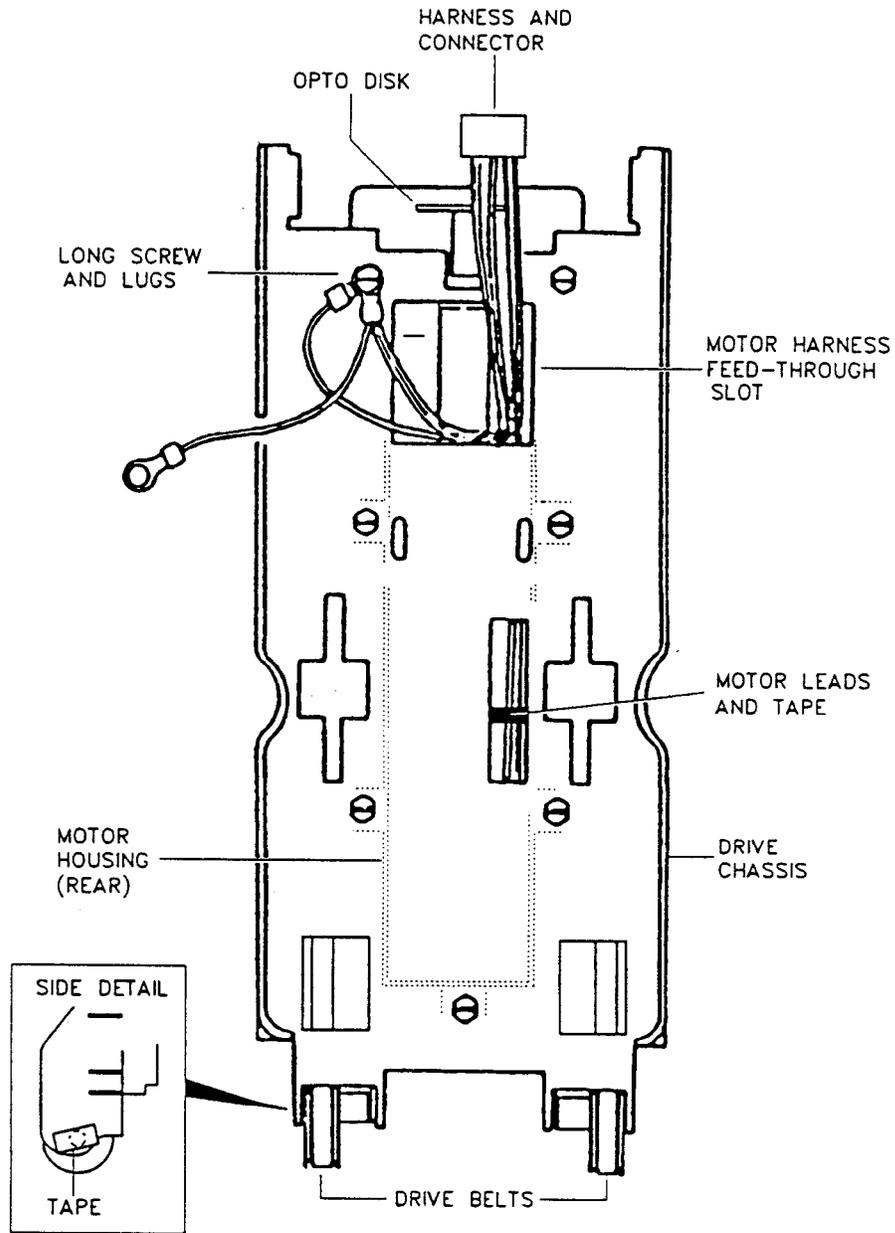
Figure 3. Plastic Motor Drive Chassis, Screws, and Details

NOTE: A SMALL PIECE OF TAPE IS USED TO SECURE EACH LOWER PULLEY SHAFT. IF THIS TAPE IS REMOVE FOR RENEWING BELTS OR LOWER PULLEYS, THE TAPE MUST BE REPLACED.

1. Set the motor housing on a flat surface with the motors facing upward. Note the location of the wire lugs under the screw head in the upper left corner of the motor chassis (Figure 3). The screw and lugs must be reinstalled in the same location. Also note the slot where the motor harness and connector feed through the drive chassis plate. The harness must be reinstalled through the same slot.

2. Red, green, and black motor harness leads are visible through the plastic cover plate, and are taped to the stacker motor gear box (Figure 3). When you reassemble the motor drive chassis, route and tape these leads exactly as they appear.

3. Remove the screws shown in Figure 3, then separate the motor housing from the drive chassis plate. Pull the motor harness through the feed-through slot.

11. Reposition the drive belts on the drive pulleys and drop the transport motor into the motor housing. Route the red, green, and black leads to their original positions across the stacker motor gearbox and tape them down as shown in Figure 3.

12. Replace tie-wraps as needed. Feed the motor connector and harness through the slot in the drive chassis (see Figure 3). Before you reinstall any screws, confirm that there are three green wires on the outside of the motor chassis. Also confirm that the red, green, and black leads are visible in the slot, as shown in Figure 3. Finally, confirm that no wires will be pinched when the screws are reinstalled.

13. Insert the long screw through the large and small ring lugs and reinstall the screw in the original position shown in Figure 3. CAUTION: This is a 2½-turn screw! Lightly tighten the screw, taking care not to strip the threads.
