SIGMA MONITORS

TOEI COLOR DISPLAY / MODEL TC-V814H

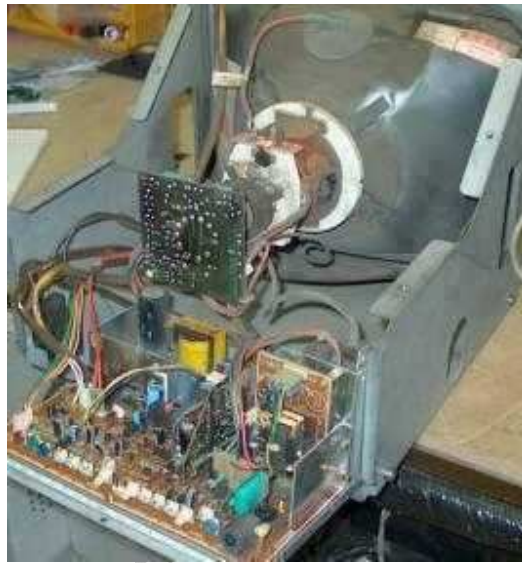
COMMON PROBLEMS:

VERT PROBLEMS

VERT DISTORTION (HOUR GLASS) PIN-CUSHION

VERT LINE IN CENTER OF SCREEN

VERT & HORIZ DISTORTION

HORIZ PROBLEMS (BLACK LINES)

VERT ROLL

Could describe a problem and direct you to the correct area Like for Dark on left side of screen - replace C28 or Hour Glass (Pin-Cushion) problem replace C601 - C602 - C604. But if you did a complete cap job - you do not really need to know that.

For about 85% of all problems, doing a complete Capacitor Job (replacing all Capacitors) should fix the problem. There is on 32 Capacitors. And when you figure the price of a Capacitor it's just best to replace them all at one time.

The following list of Electrolytic Capacitors has been recommended for the board in the TOEI Monitor.
